# Inspection Summary

123 Sample Street, Sample City, FL 00000  
Sample Customer · July 10, 2026

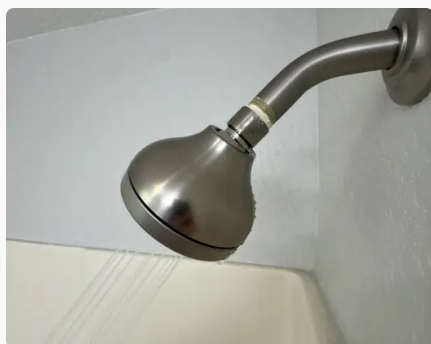
### 13.D1 Showerhead – Leaking

The showerhead was leaking at the time of inspection. Left unaddressed, plumbing conditions of this kind can allow moisture to reach surrounding materials, and moisture-related damage typically grows more costly over time.

Recommend repair by a qualified professional.

**Recommendation:** Repair

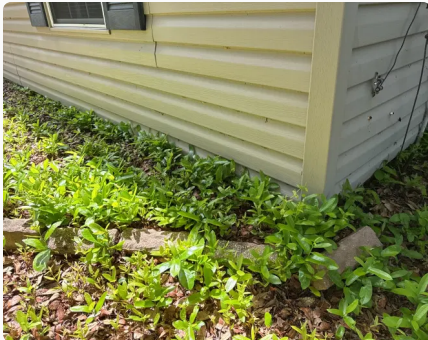
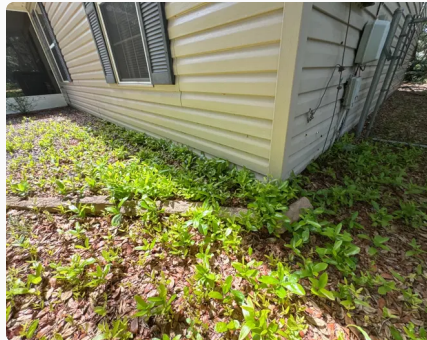
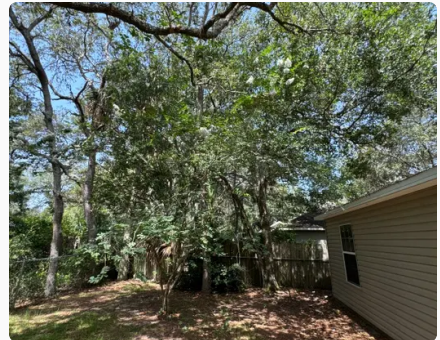
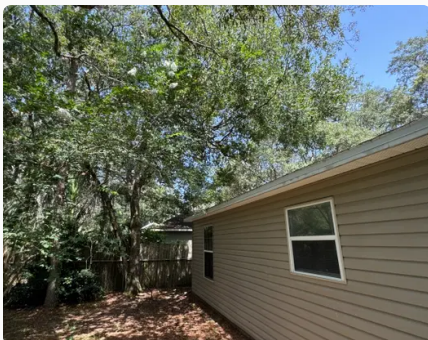
02.D3 Vegetation – Encroaching Structure

Vegetation was observed in contact with or encroaching upon the structure. Plant material in direct contact with a building can retain moisture against exterior surfaces and may provide a pathway for insects or pests to access the structure.

Trimming vegetation back from the structure is recommended to maintain clearance and reduce the potential for moisture-related deterioration at affected exterior surfaces. A qualified landscaping professional or general contractor can perform this work as conditions warrant.

**Recommendation:** Service / Maintain

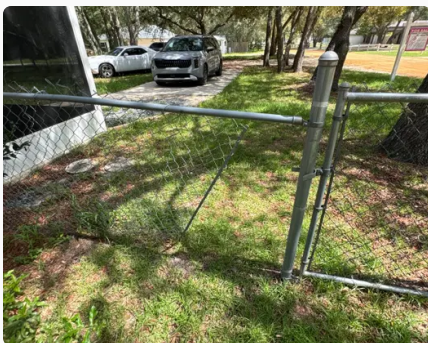
#### 02.D6 Fencing – Damaged or Missing Sections

Damaged or missing sections were observed at the fencing. This condition may reduce the effectiveness of the fence as a boundary barrier and can allow unintended access to the property. Left unaddressed, the affected areas may be subject to continued deterioration.

Evaluation and correction by a qualified fencing contractor is recommended to restore the fence to proper condition.

**Recommendation:** Service / Maintain

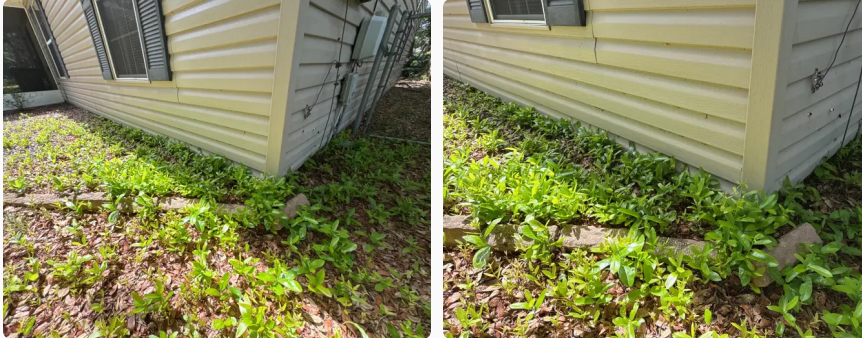
#### 04.D1 Wall Covering – Wall Covering Contacting Soil

Wall covering material at the home exterior was observed in direct contact with the soil. This condition is inconsistent with standard installation practices, as exterior wall coverings are intended to terminate above grade.

When wall covering materials contact soil, they are exposed to sustained moisture, which may contribute to deterioration of the material over time. This condition may also increase the potential for moisture intrusion at the base of the wall assembly and can create conditions conducive to wood-destroying organism activity.

It is recommended that a qualified contractor evaluate the condition and correct as needed. Correction typically involves adjusting the grade or addressing the termination height of the wall covering to establish appropriate clearance above soil.

**Recommendation:** Improve Grading

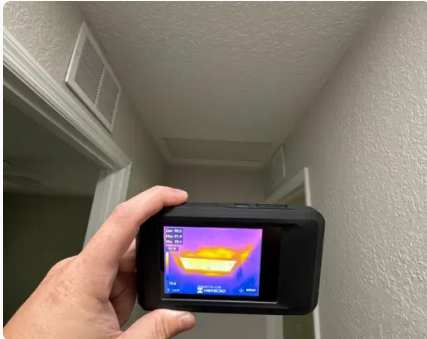
**06.D1 Hatch Insulation – Missing**

No hatch insulation was observed where one would be expected. Insulation and ventilation work together to manage heat and moisture; a shortfall in either can raise energy costs and promote condensation-related problems. Recommend installation by a qualified professional.

**Recommendation:** Install

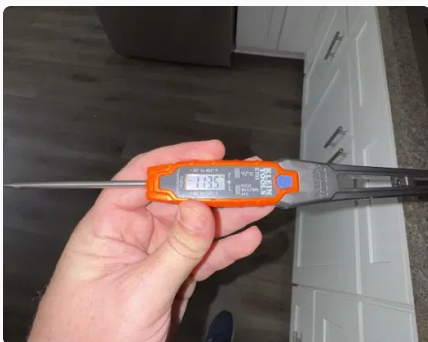
**10.D2 Hot Water Temperature – Below Minimum (Below 120°F)**

Below minimum (below 120°F) was observed at the hot water temperature. Left unaddressed, plumbing conditions of this kind can allow moisture to reach surrounding materials, and moisture-related damage typically grows more costly over time. Recommend adjustment by a qualified professional.

**Recommendation:** Adjust

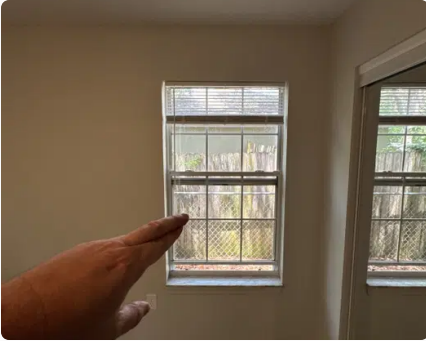
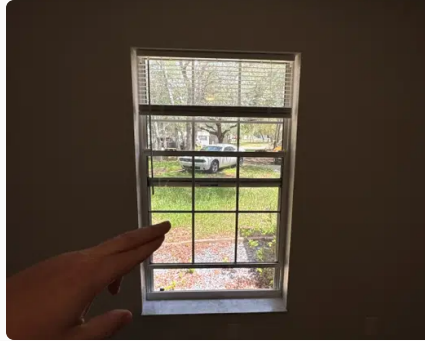
#### 11.D1 Interior Windows – Hard to Operate

Hard to operate was observed at the interior windows. Beyond day-to-day function, openings in the building envelope also affect weather resistance and energy efficiency, so conditions here tend to have both convenience and moisture implications. Recommend adjustment by a qualified professional.

**Recommendation:** Adjust

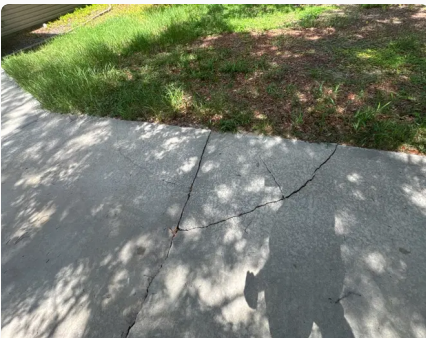
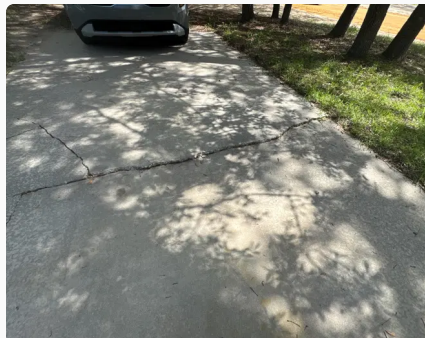
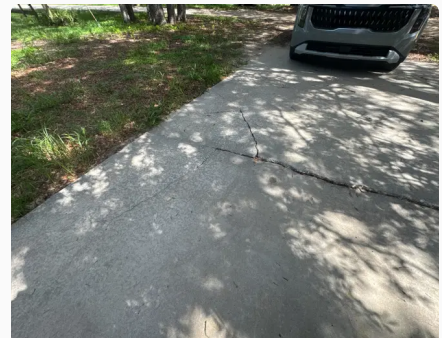
#### 02.D1 Driveway – Moderate Cracking

Cracking and vertical displacement were observed in the concrete driveway slab at the time of inspection. Displacement of approximately 1 inch was noted at affected crack locations, with heaving of the slab surface present in multiple areas. The driveway surface is not severely deteriorated overall, but the displacement and cracking represent a notable departure from acceptable condition.

A qualified concrete or flatwork contractor should be consulted to evaluate the affected sections and recommend appropriate corrective action, which may include slab grinding, mudjacking, or panel replacement.

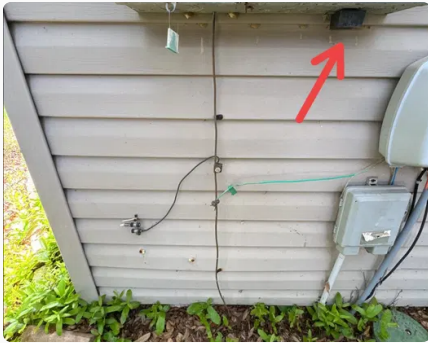
**08.D3 SPD – Wired Direct to Main & Not On Breaker**

The surge protective device (SPD) was observed to be wired directly to the main lugs of the electrical panel rather than connected through a dedicated circuit breaker. Without an overcurrent protective device on the SPD circuit, the wiring and device are not protected in the event of a fault condition.

A licensed electrician should be consulted to evaluate the installation and reconnect the SPD through an appropriately rated circuit breaker in accordance with the manufacturer's installation requirements and applicable electrical standards.
