INSPECTION REPORT · FULL REPORT

# 123 Sample Street

Sample City, FL 00000

**Inspection Date:** July 10, 2026

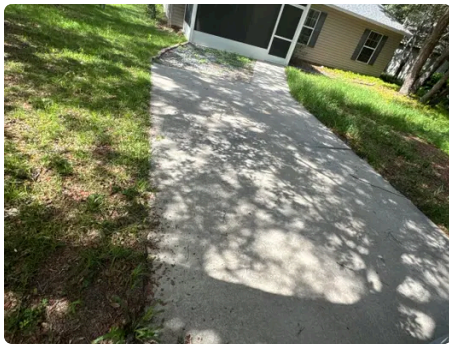
### 02.D1 Driveway – Moderate Cracking

HIGH SEVERITY

Cracking and vertical displacement were observed in the concrete driveway slab at the time of inspection. Displacement of approximately 1 inch was noted at affected crack locations, with heaving of the slab surface present in multiple areas. The driveway surface is not severely deteriorated overall, but the displacement and cracking represent a notable departure from acceptable condition.

A qualified concrete or flatwork contractor should be consulted to evaluate the affected sections and recommend appropriate corrective action, which may include slab grinding, mudjacking, or panel replacement.

**Recommendation:** Service / Maintain

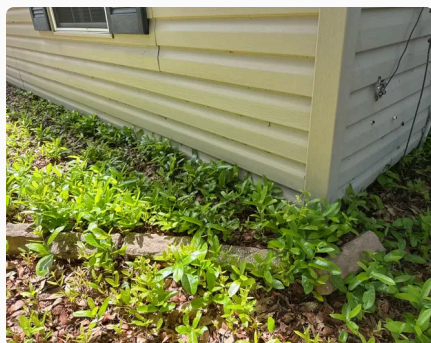
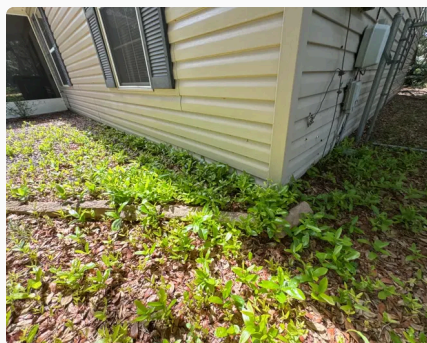
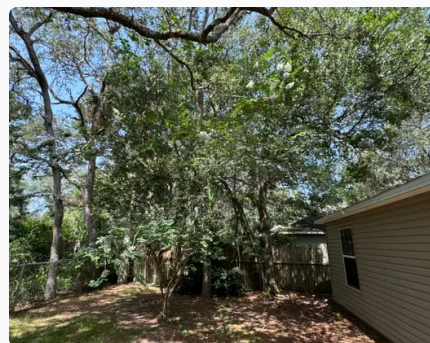
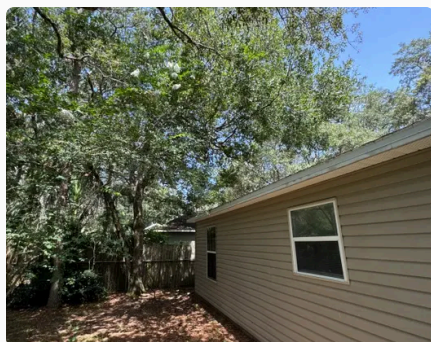
Vegetation was observed in contact with or encroaching upon the structure. Plant material in direct contact with a building can retain moisture against exterior surfaces and may provide a pathway for insects or pests to access the structure.

Trimming vegetation back from the structure is recommended to maintain clearance and reduce the potential for moisture-related deterioration at affected exterior surfaces. A qualified landscaping professional or general contractor can perform this work as conditions warrant.

**Recommendation:** Service / Maintain

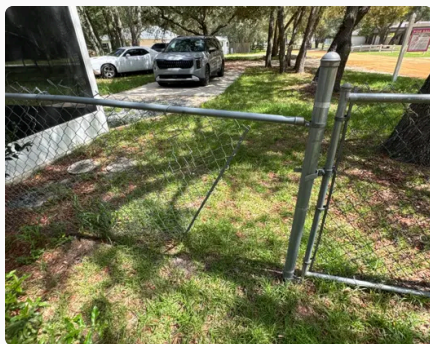
**02.D6 Fencing – Damaged or Missing Sections****MEDIUM SEVERITY**

Damaged or missing sections were observed at the fencing. This condition may reduce the effectiveness of the fence as a boundary barrier and can allow unintended access to the property. Left unaddressed, the affected areas may be subject to continued deterioration.

Evaluation and correction by a qualified fencing contractor is recommended to restore the fence to proper condition.

**Recommendation:** Service / Maintain

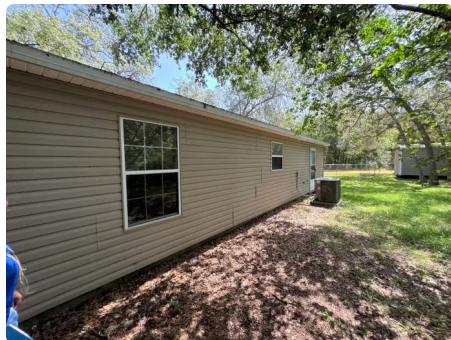
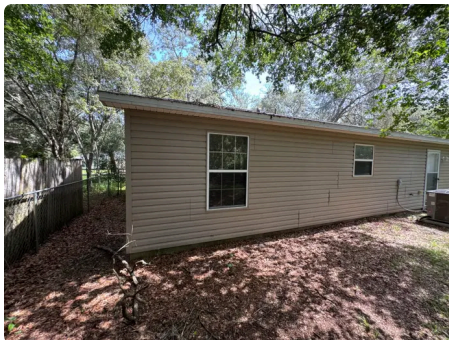
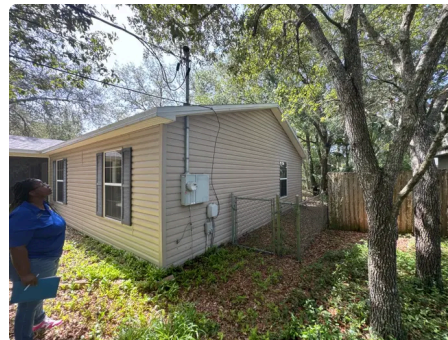
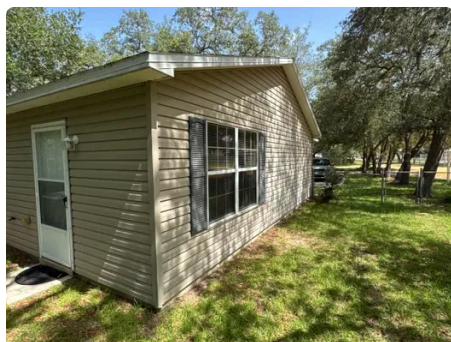
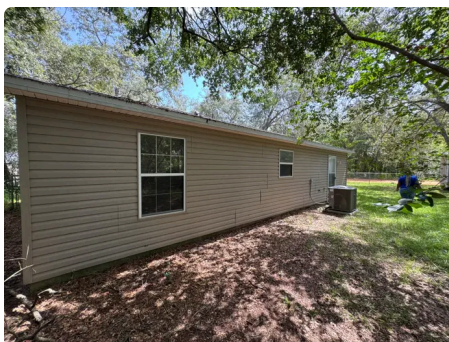
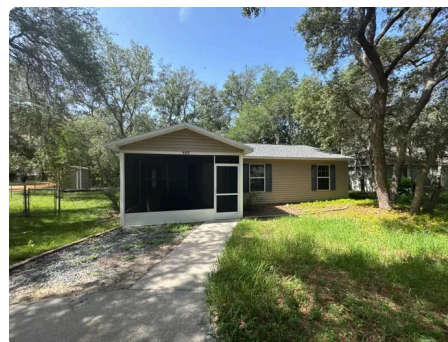
### 04.D1 Wall Covering – Wall Covering Contacting Soil

Wall covering material at the home exterior was observed in direct contact with the soil. This condition is inconsistent with standard installation practices, as exterior wall coverings are intended to terminate above grade. When wall covering materials contact soil, they are exposed to sustained moisture, which may contribute to deterioration of the material over time. This condition may also increase the potential for moisture intrusion at the base of the wall assembly and can create conditions conducive to wood-destroying organism activity.

It is recommended that a qualified contractor evaluate the condition and correct as needed. Correction typically involves adjusting the grade or addressing the termination height of the wall covering to establish appropriate clearance above soil.

**Recommendation:** Improve Grading

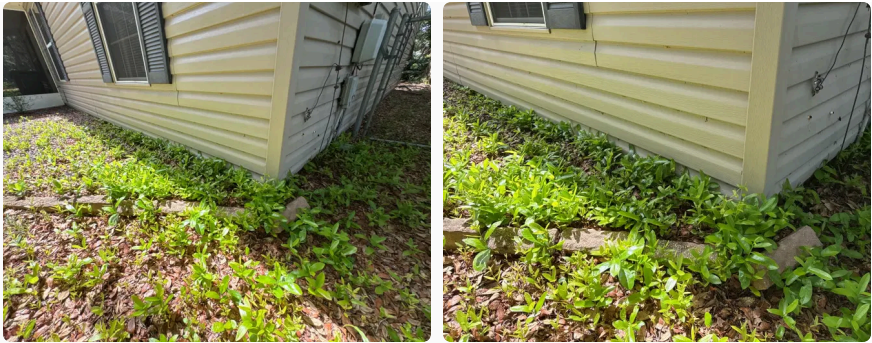
MEDIUM SEVERITY

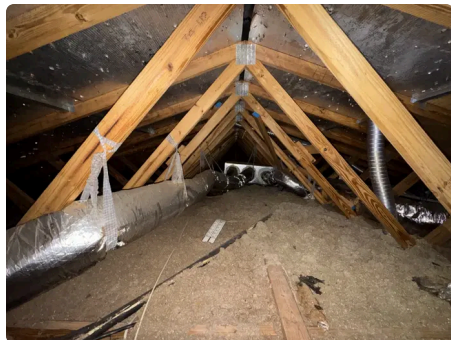
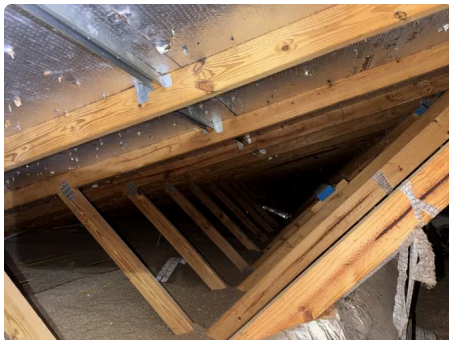
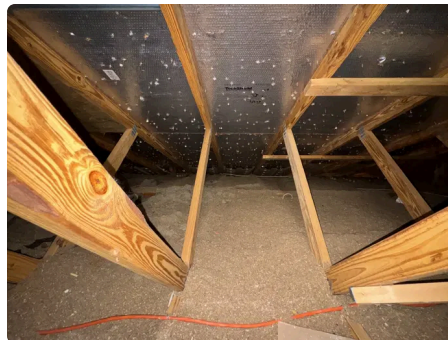
### Radiant Barrier – Overview

A radiant barrier was observed installed within the attic space of the home. Radiant barriers are reflective insulation systems typically composed of a highly reflective material, most commonly aluminum foil, applied to one or both sides of a substrate such as kraft paper, plastic film, or oriented strand board (OSB). The primary function of a radiant barrier is to reduce radiant heat transfer, which occurs when heat energy travels from a warm surface to a cooler one without direct contact.

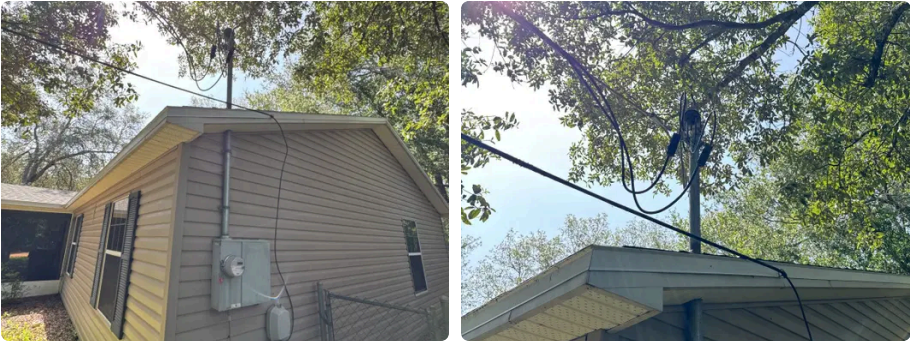
08.D1

Overhead Conductors – Too Close to Trees

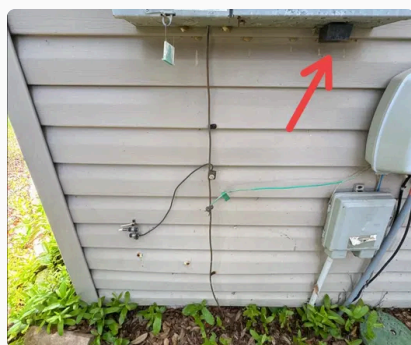
The surge protective device (SPD) was observed to be wired directly to the main lugs of the electrical panel rather than connected through a dedicated circuit breaker. Without an overcurrent protective device on the SPD circuit, the wiring and device are not protected in the event of a fault condition.

A licensed electrician should be consulted to evaluate the installation and reconnect the SPD through an appropriately rated circuit breaker in accordance with the manufacturer's installation requirements and applicable electrical standards.

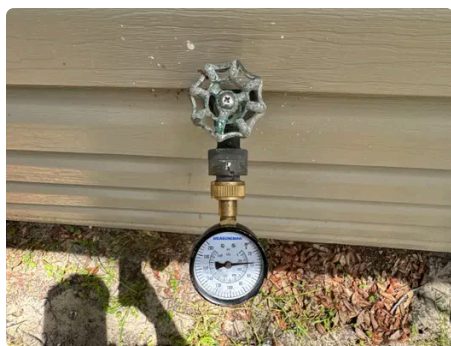
#### 10.D1 Water Pressure – Low (<40 PSI)

| STATIC WATER PRESSURE READING | 35 PSI |

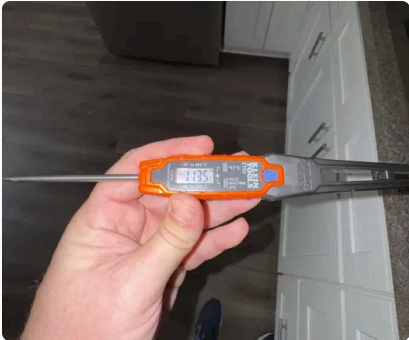
Below minimum (below 120°F) was observed at the hot water temperature. Left unaddressed, plumbing conditions of this kind can allow moisture to reach surrounding materials, and moisture-related damage typically grows more costly over time. Recommend adjustment by a qualified professional.

Recommendation: Adjust

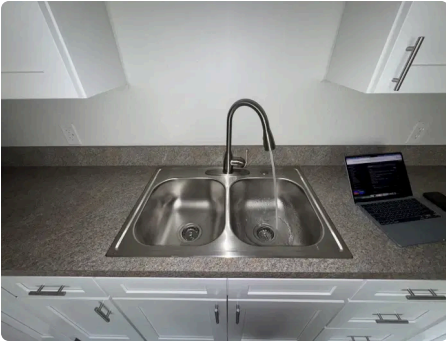
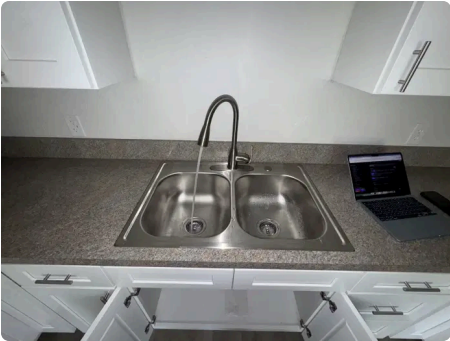
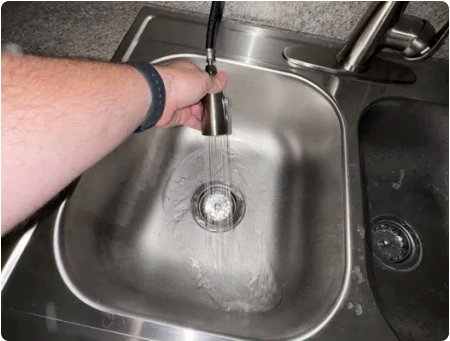
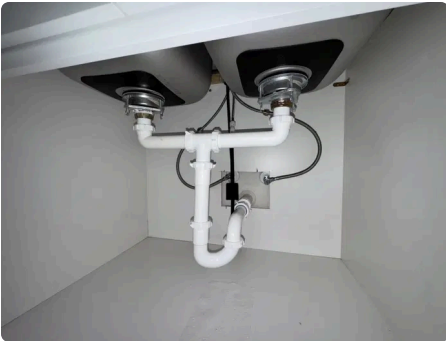
| FAUCET CONDITIONS | Serviceable |
| DRAIN FUNCTIONAL? | Drains freely |
| UNDER-SINK CONDITIONS | Serviceable |

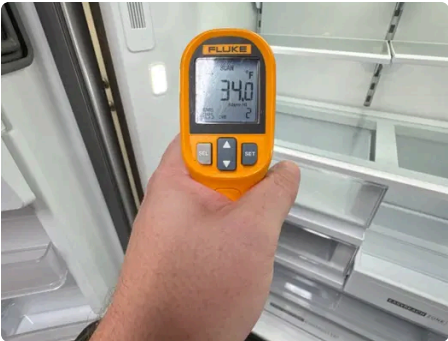
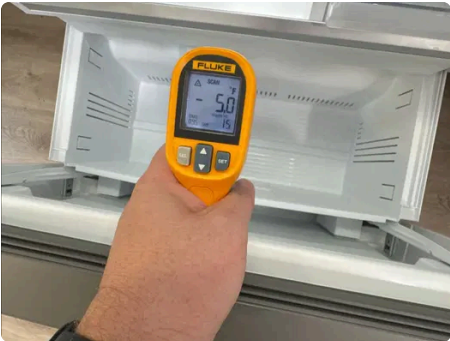
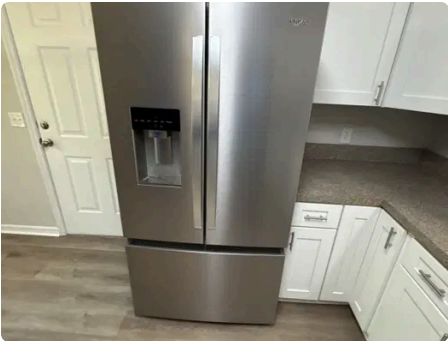
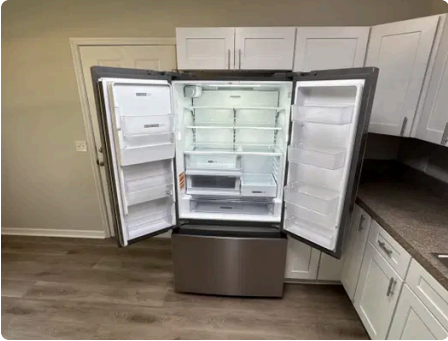
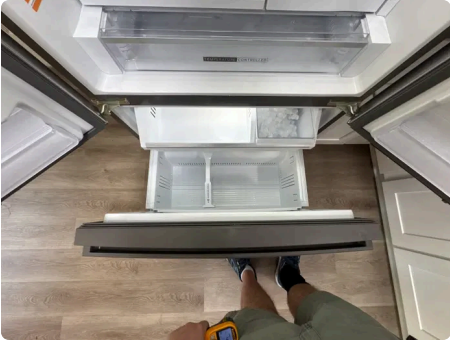
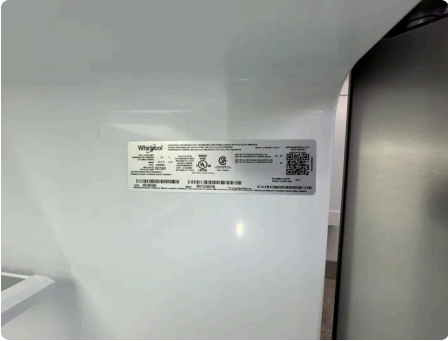
Refrigerator

| REFRIGERATOR STATUS | Operational |
| CONDITIONS | Serviceable |
| WATER LINE | Yes — functional |

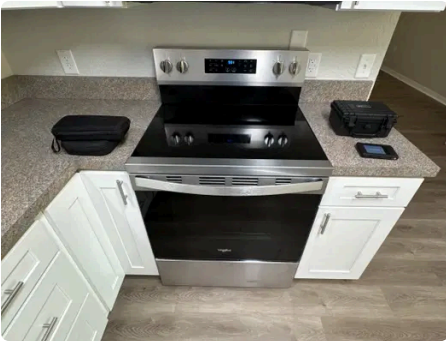
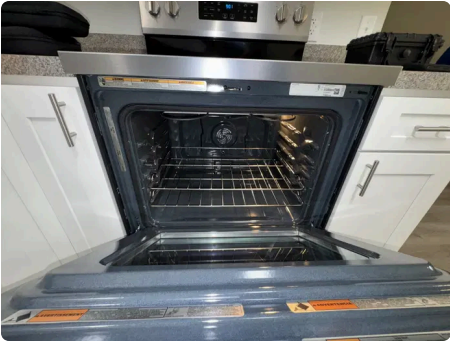
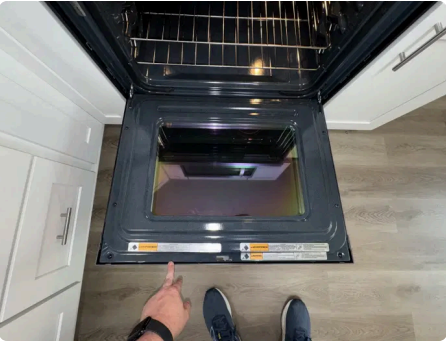
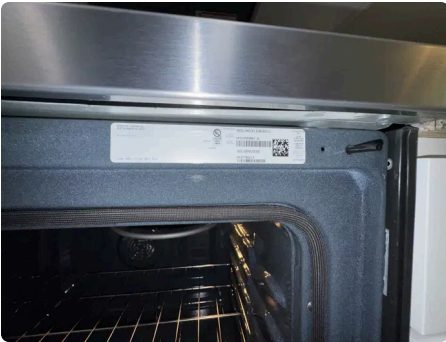
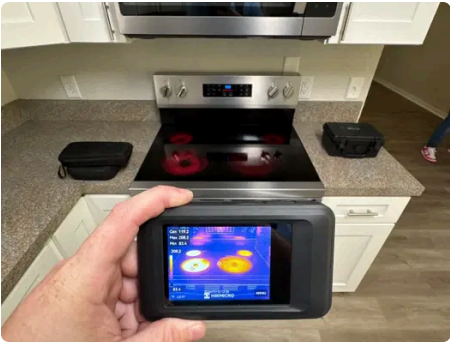
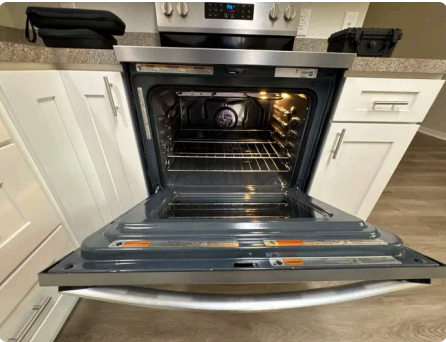
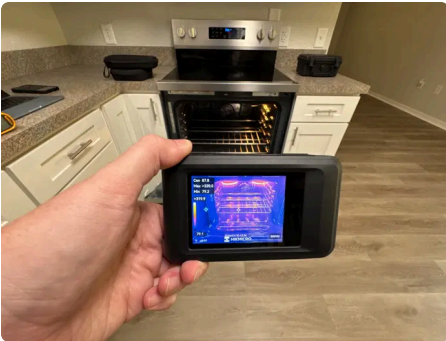
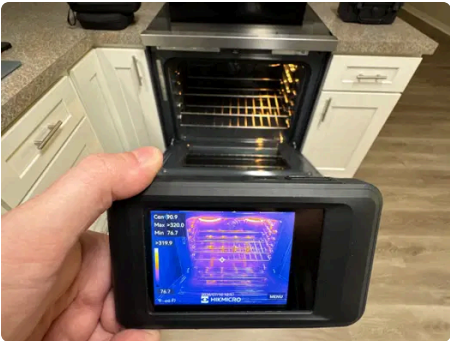
Range / Oven / Cooktop

| FUEL TYPE | Electric |
| ANTI-TIP DEVICE INSTALLED? | Yes |
| CONDITION | Serviceable |

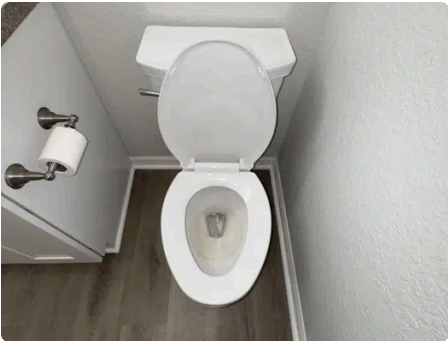
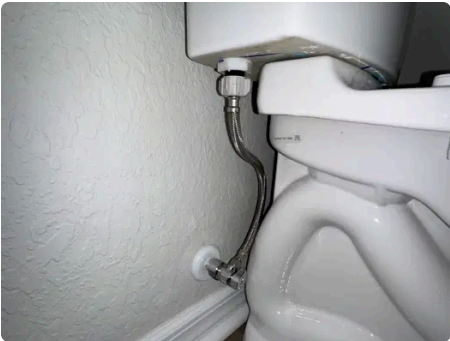
| TANK CONDITIONS | Serviceable |
| SHUTOFF VALVE CONDITION | Serviceable |

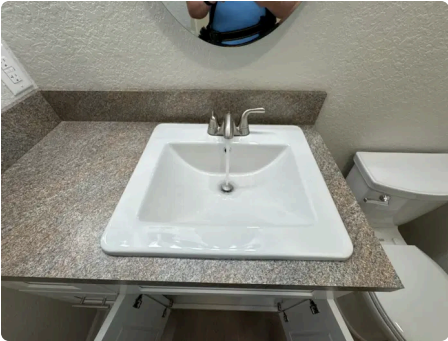
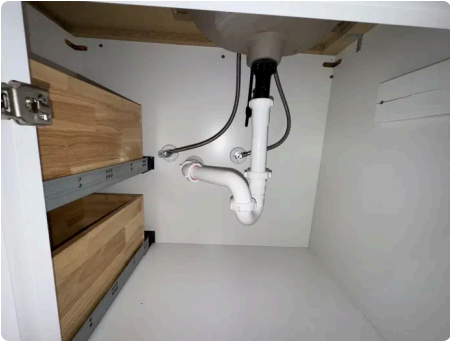
Bathroom Sink

| FAUCET CONDITIONS | Serviceable |
| DRAIN FUNCTIONAL? | Drains freely |
| UNDER-SINK CONDITIONS | Serviceable |

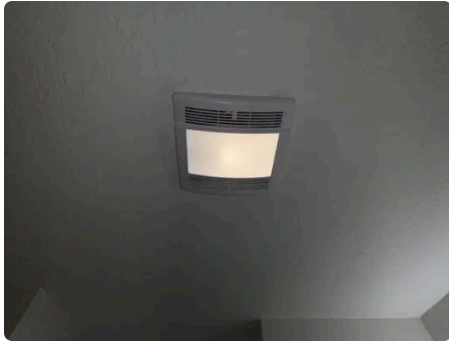
| VENTILATION TYPE | Exhaust fan |
| FAN CONDITION | Serviceable |

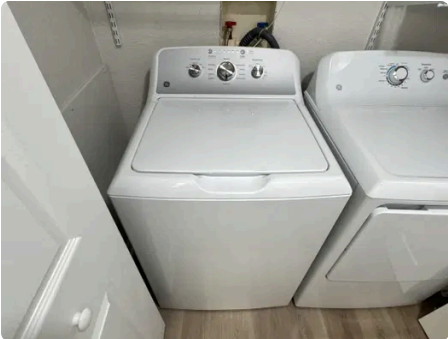
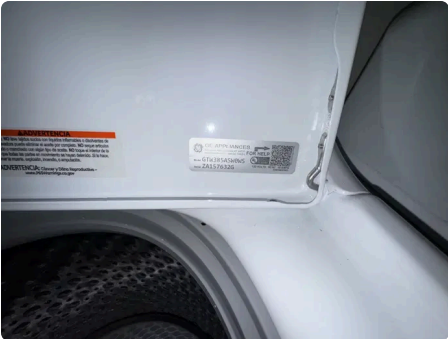
| SUPPLY VALVE CONDITIONS | Serviceable |
| SUPPLY HOSE TYPE | Braided stainless |
| DRAIN/STANDPIPE CONDITIONS | Serviceable |

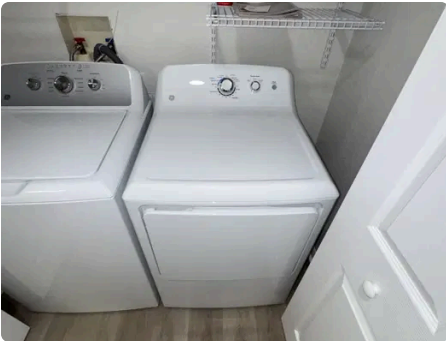
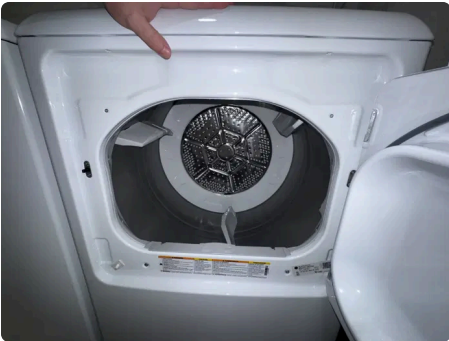
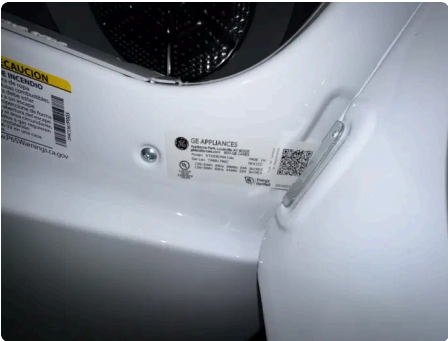
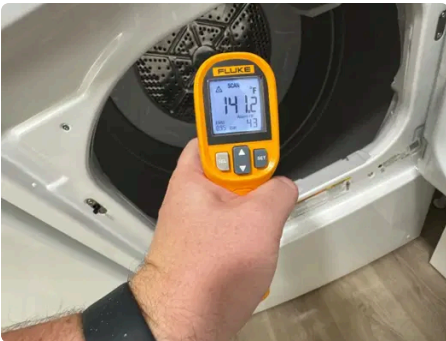
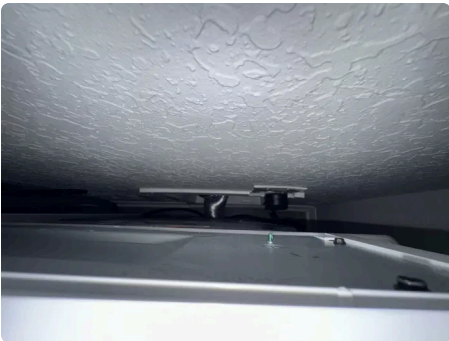
| EXHAUST VENT CONDITIONS | Serviceable |
| DRYER CONDITIONS | Serviceable |
